# Medford High School

Medford Comprehensive High School  
Building Committee Meeting

12/22/2025

# Building Investigations

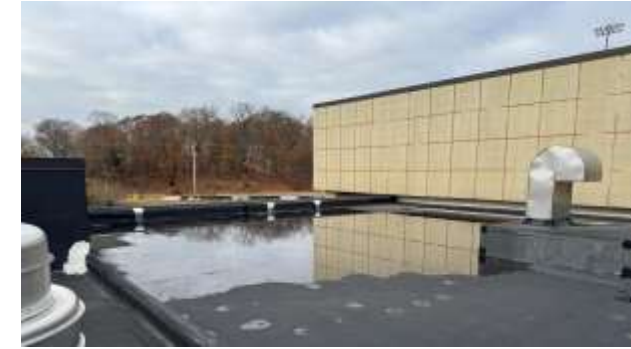
- **No thermal insulation** present in the exterior wall construction, with many sealant failures.
- **Leaks and areas of ponding are present across entire roof**, all vintages of roofing (2001, 2015)

*Significant Ponding on Roof Membrane*

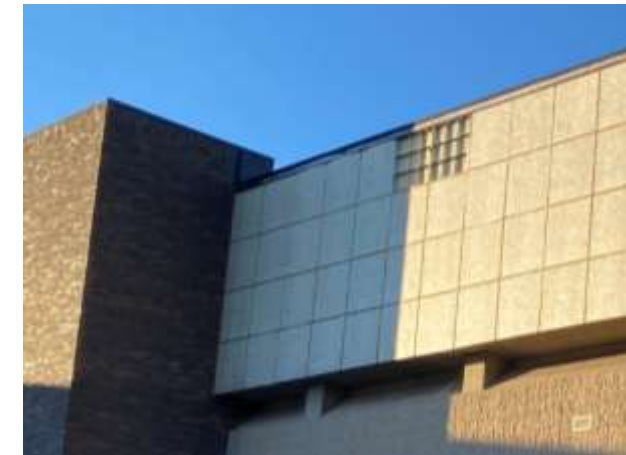
- Exterior materials consist of the original exposed **cast-in-place concrete**, **brick masonry veneer**, **single pane non-thermally broken windows** and **“Kalwall”** translucent panels. Materials exhibit varying degrees of wear, with the original windows and Kalwall in poor / failing condition.

*Yellowed and Missing Kalwall Panels*

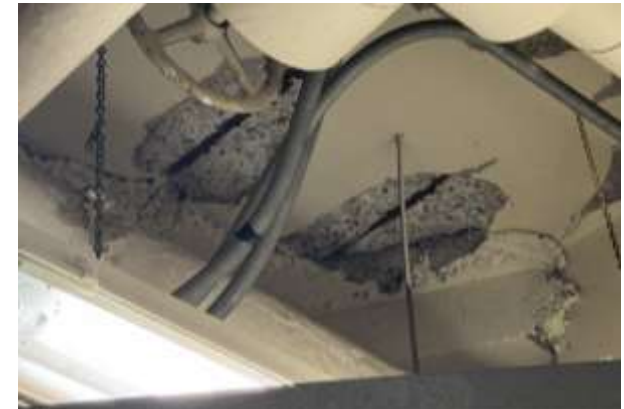
- Infill masonry walls not seismically braced at the top of the walls
- **Exposed rebar** in the underside of the concrete pool deck
- Settlement of the slab on grade in Wing C

*Exposed Rebar Below Pool Deck*

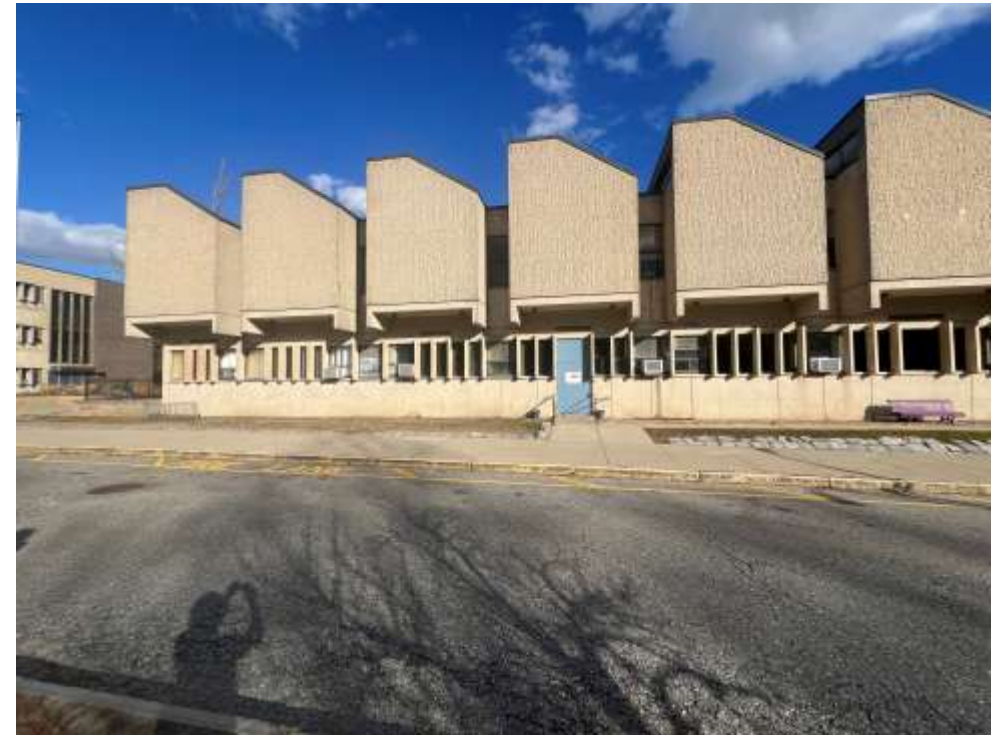
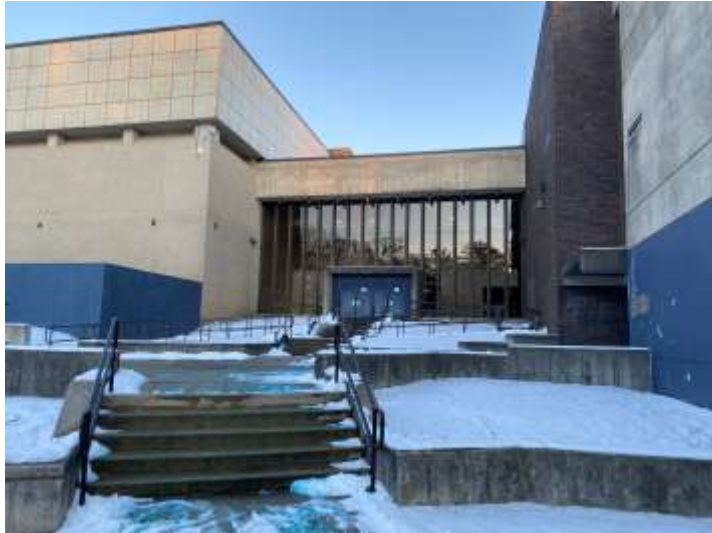
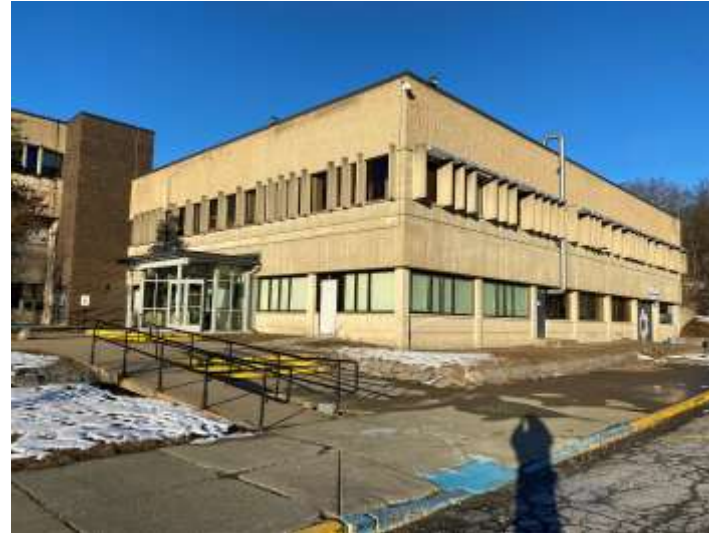
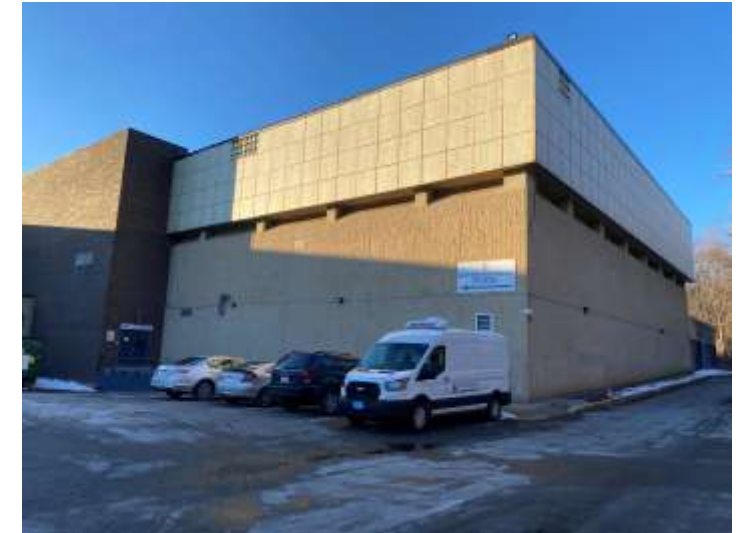
- Exterior materials consist of the original exposed cast-in-place concrete, brick masonry, single pane non-thermally broken windows and “Kalwall” translucent panels
- No thermal insulation present in the exterior wall construction
- Exterior materials are experiencing varying degrees of wear, with the Kalwall panels experiencing severe yellowing with multiple panels having holes and missing surfaces

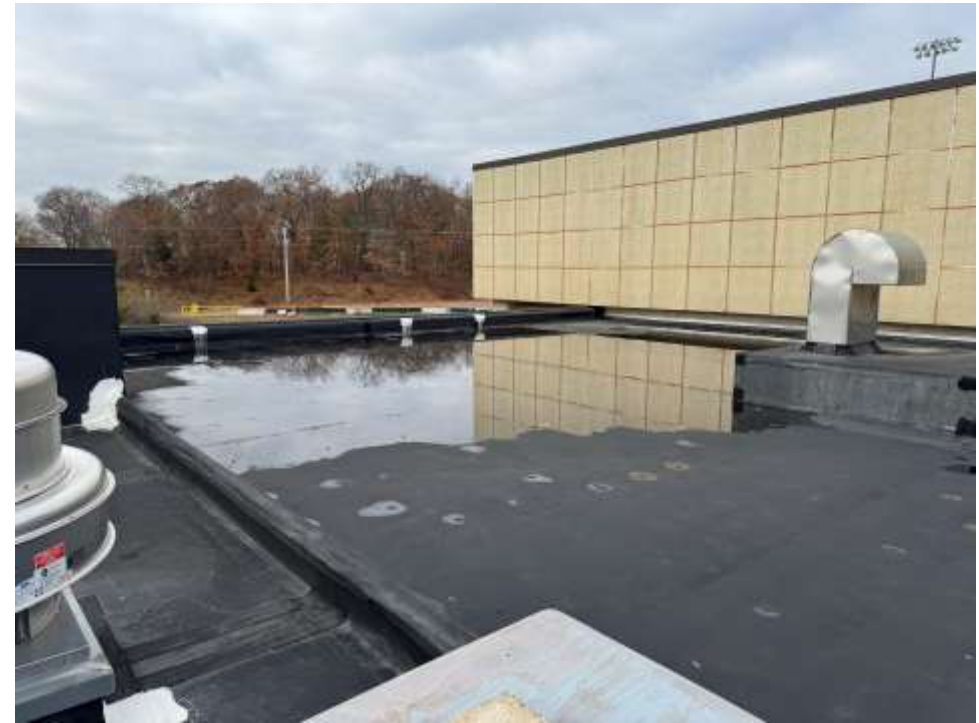
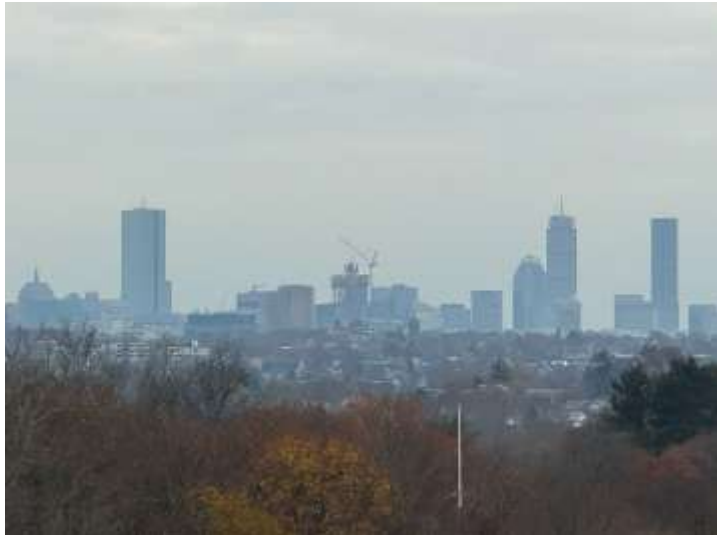
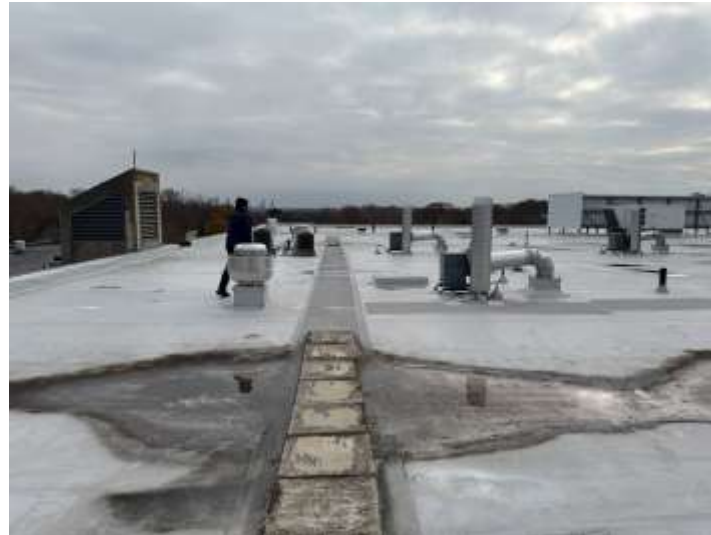
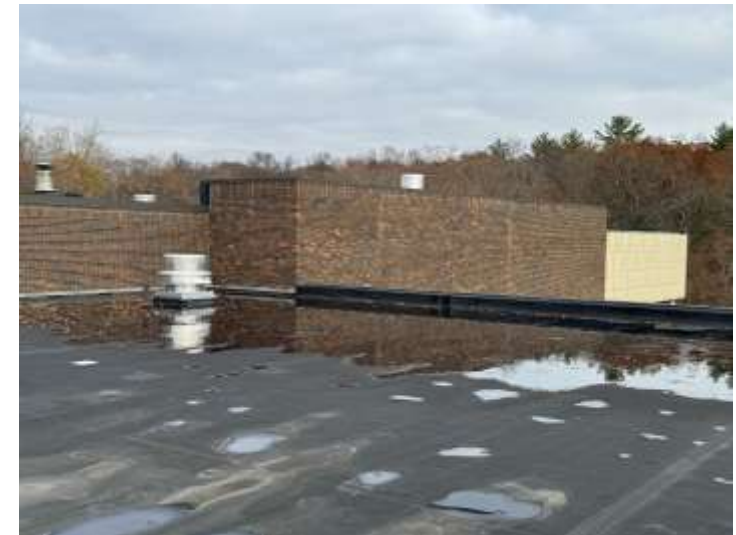
- Majority of roof membrane was replaced in 2001 with a black EPDM membrane, and is now near or at end of life
- B Wing roof was redone with the Science Lab Renovation in 2015, and is a white PVC membrane
- Leaks and areas of ponding are present across entire roof surface, in all vintages of roofing
- Pool roof membrane/deck has seen accelerated deterioration due to pool moisture from below

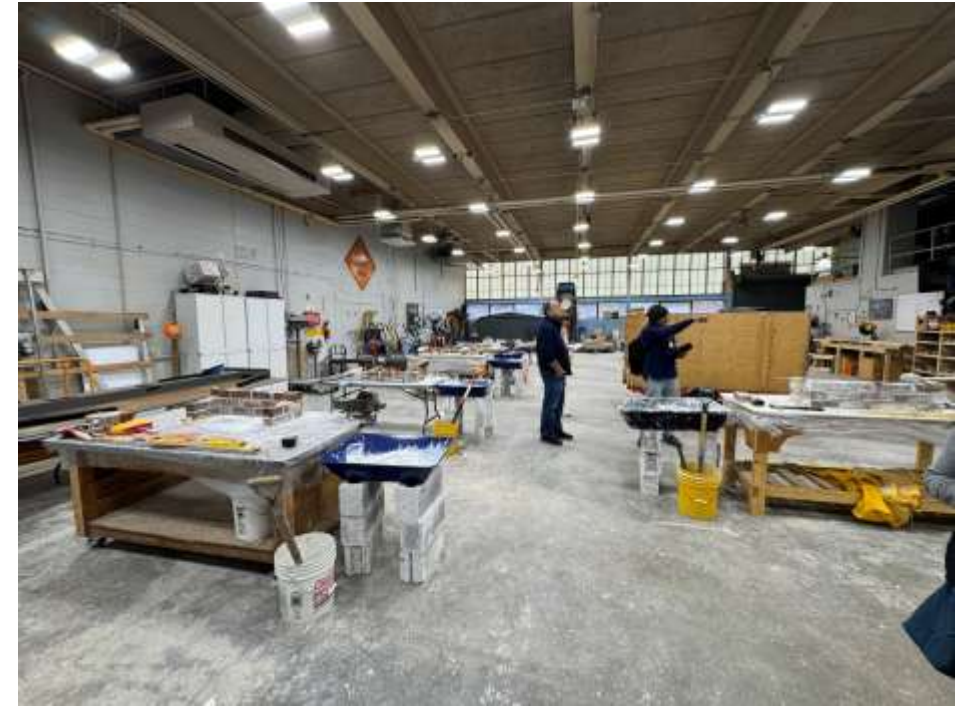
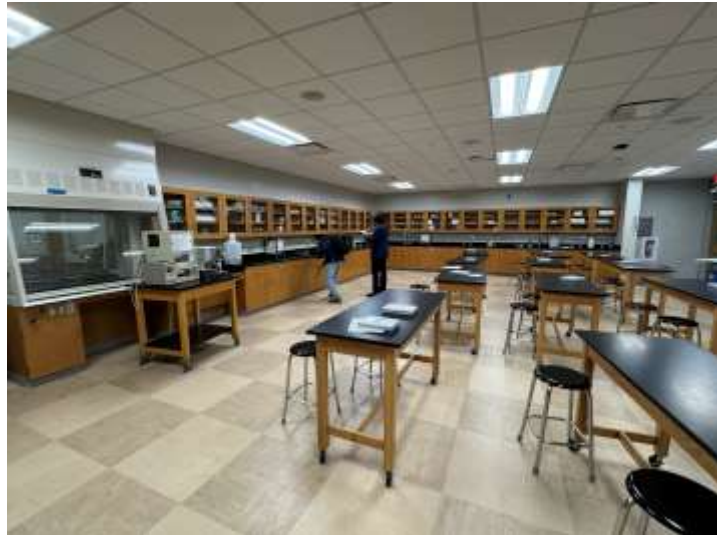
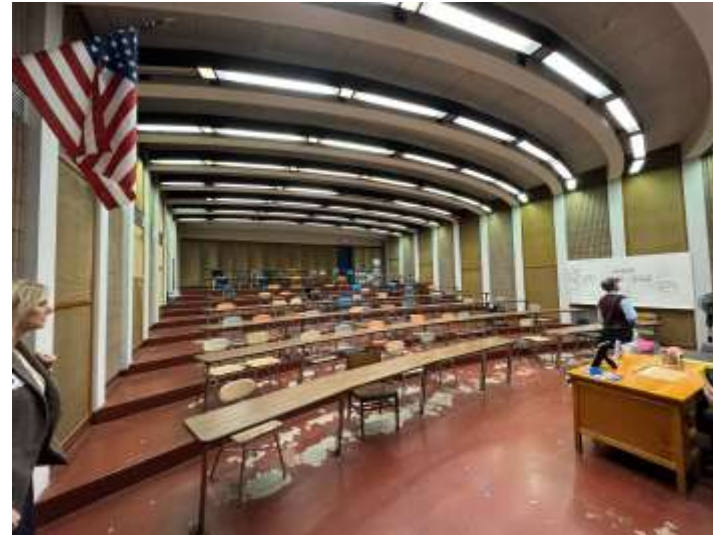
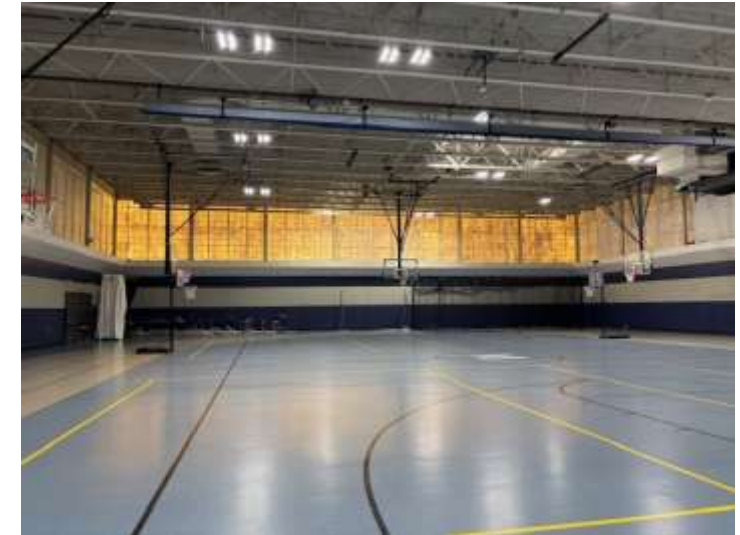
- Majority of the interior is intact from the 1970 original construction, with the science lab renovation on the third floor of B wing in 2015, and various smaller interior renovations for Medford Community Media studio and CTE programs having been completed more recently
- Interior partitions primarily concrete masonry units, with wide variety of finishes that are generally in fair to poor condition, aside from the limited later renovations

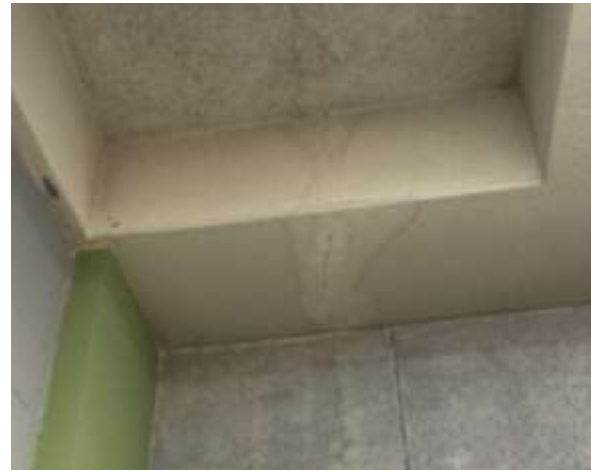
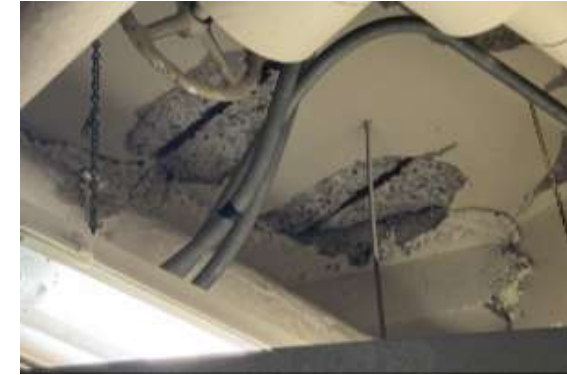
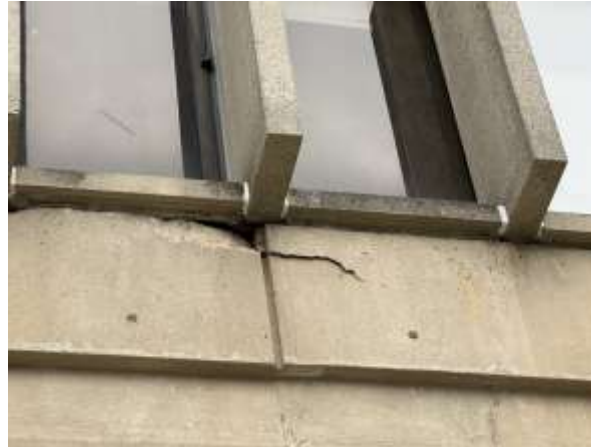
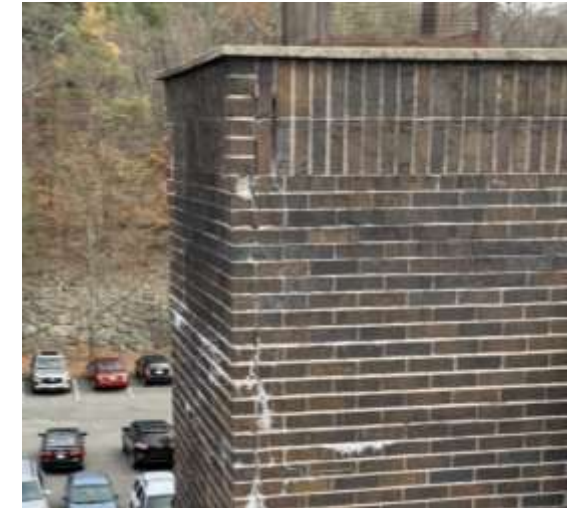
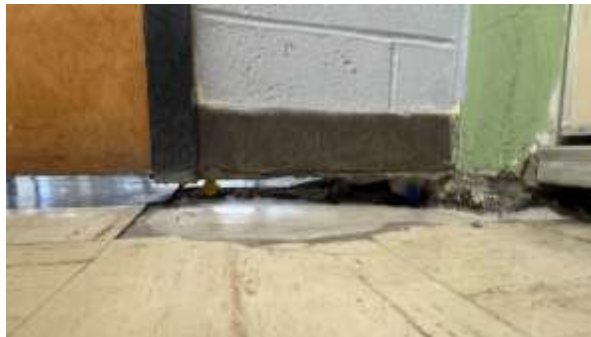
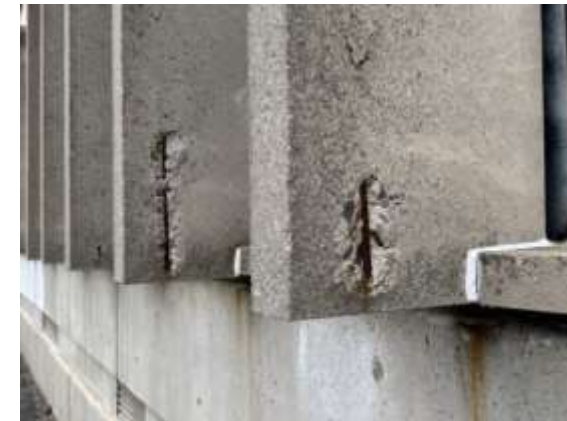
- No conventional lateral force resisting system
- Snow drift loads not considered in original design
- Earthquake design does not appear to be a consideration in the original design
- Original design wind load is less than current code prescribed criteria
- Existing  $\frac{3}{4}$ " expansion joints not sized for lateral movements of current wind and seismic loads
- Infill unreinforced masonry walls not seismically braced at the top of the walls
- Exposed rebar in the underside of the concrete pool deck
- Settlement of the slab on grade in Wing C
- Miscellaneous concrete cracks in concrete and masonry walls
- Exterior brick requires repair in several areas
- Water damage observed in several locations

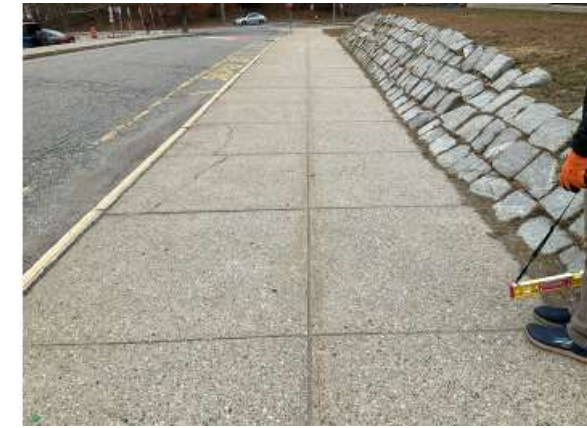
- No accessible **passenger loading zones** provided
- Majority of **accessible parking spaces** have slope issues and/or non-compliant signage
- **Accessible routes** have various issues of non-compliance:
  - Excessive running and/or cross slopes along walkways, curb ramps, and ramps
  - Abrupt changes in level
  - No curb ramps provided at crosswalks
- Several **stairs** lack compliant handrails
- All **public entrances** are required to be accessible. Majority of entrances have barriers:
  - Some have steps and/or lead to stairs
  - Most door landings have excessive slopes
  - Many doors are too narrow and/or lack maneuvering clearance

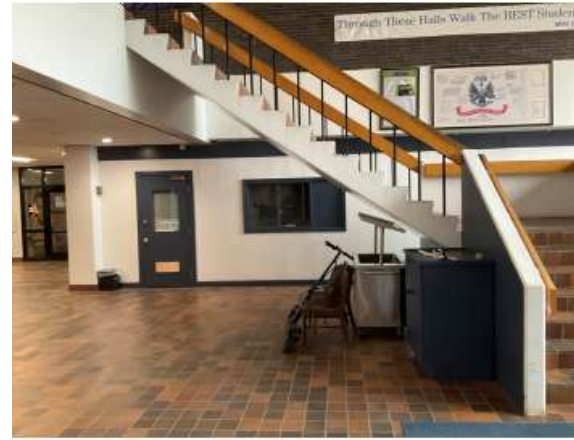
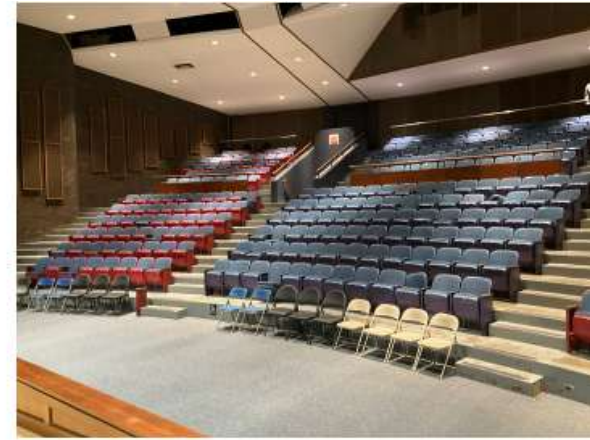
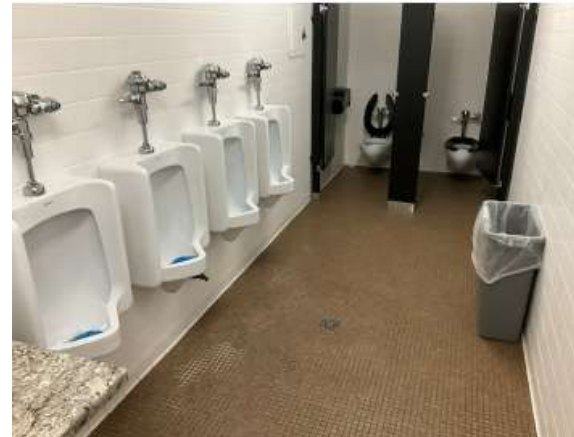
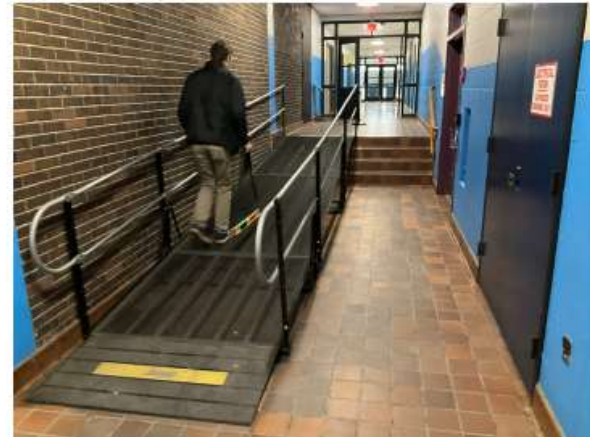
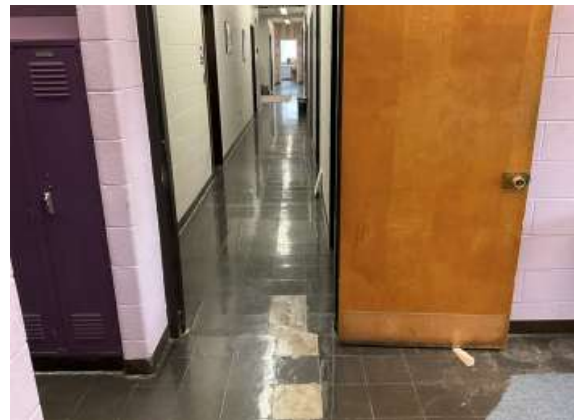
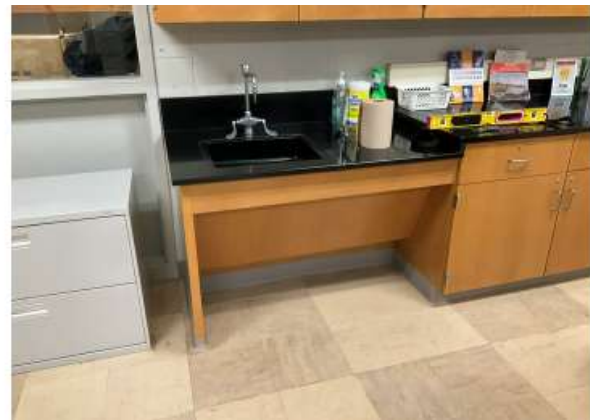
- All **stairs** lack compliant handrails and nosings
- Majority of **doors** are too narrow, have knob hardware, and/or lack maneuvering clearance
- Classroom **sinks** are inaccessible or have issues of non-compliance; including in renovated areas.
- There are no accessible **kitchens** (student/staff).
- There is no **accessible route** to the batting cages, portions of the auditorium, and one classroom due to the stairs.
- Most **toilet rooms** are inaccessible. Even designated accessible toilet rooms have significant barriers. There are no compliant **bathing fixtures** provided in any locker room.
- The **auditorium** lacks enough compliant wheelchair spaces, lacks assistive listening system, the ramp to the stage is not compliant.

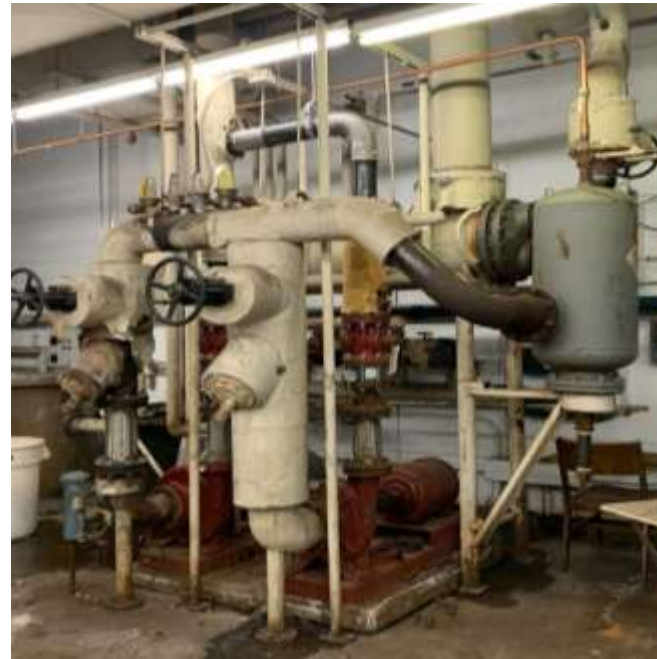
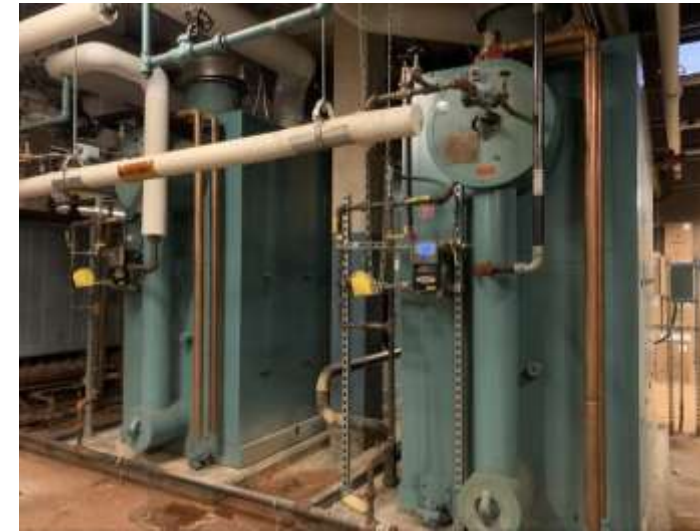
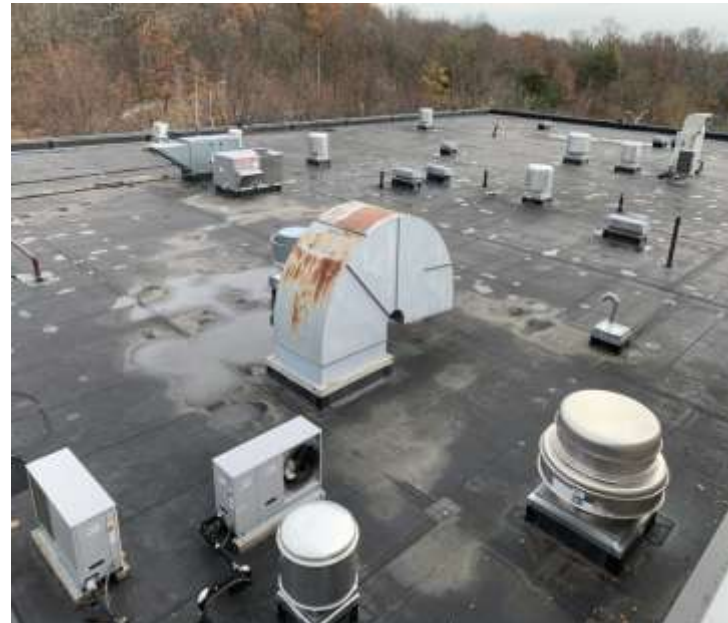
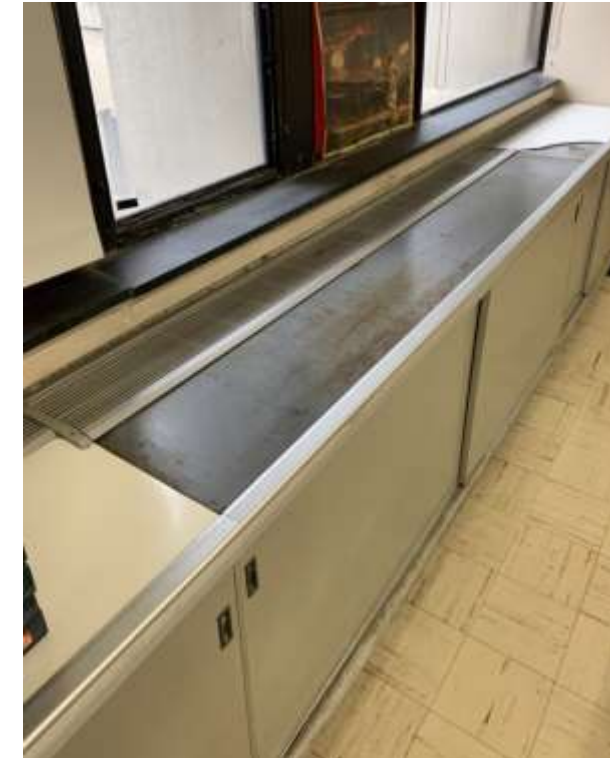
- Low pressure steam to hot water system
- Limited centralized cooling
- Antiquated pneumatic control system
- Unreliable air quality and ventilation
- Limited energy recovery
- Select upgrades in the past 20 years
- Most major equipment and distribution is past its operable lifespan
- Classroom unit ventilators create disruptive noise and uneven temperatures

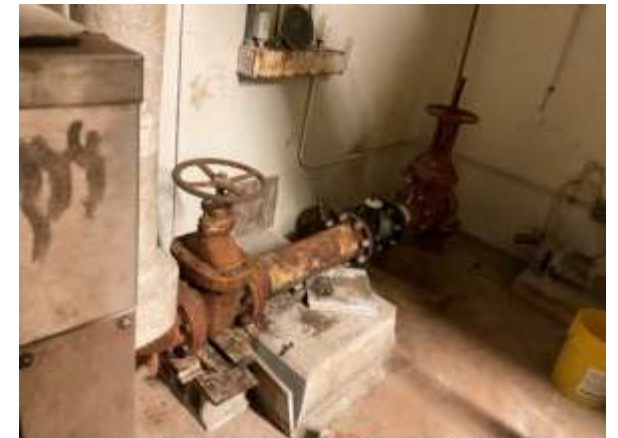
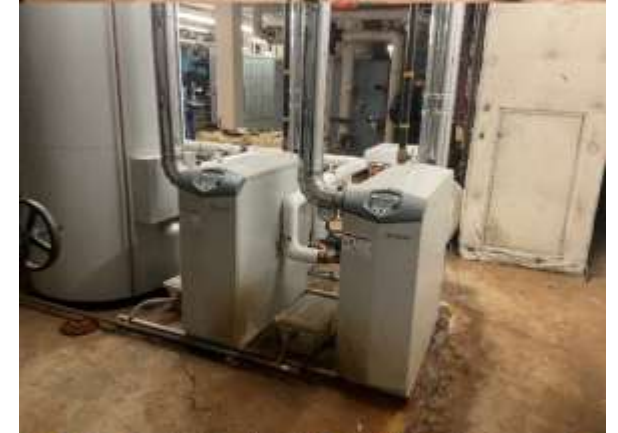
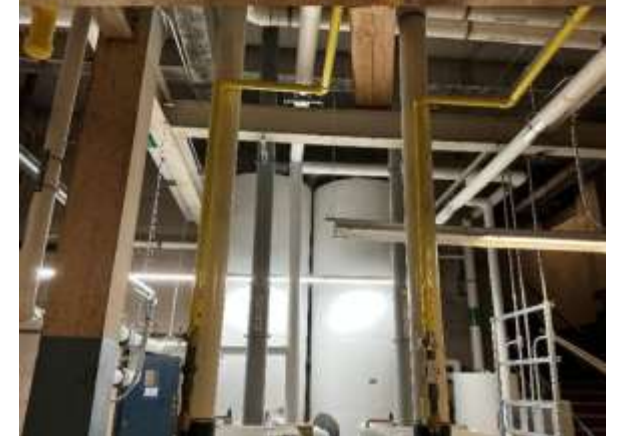
- Most of the piping where visible is poor condition and most of the insulation where visible is in fair condition. Test for lead contamination and replace hot and cold-water piping and valves throughout the building to conform to the NSF 61 and NSF 372 standards for lead-free safe drinking water Act.
- Most of the fixtures are outdated and majority of the bathrooms are do not meet with current ADA accessibility requirements.
- Non potable cold and hot water, acid waste system for science labs are provided as part of renovations in 2016 and are in good condition. Science classrooms does meet current ANSI/ISEA Z358.1 standards.
- All sinks in kitchen (except hand sinks) and floor sinks/drains must discharge through interior grease interceptor and a dedicated outdoor grease trap is required to install to handle the kitchen flows.

- 6" ductile iron main water service enters the filter room space in building F reduces to 4" at the water meter and increases to 6" to serve all the buildings.
- No backflow preventer was located at the main water supply.

- The domestic hot water needs of the buildings A,B,H,G is supported by two gas fired hot water heaters and two large 504 gal ea. Tanks located in the mechanical room of building H
- The domestic hot water needs of the buildings C,E,D,F is supported by two gas fired hot water heaters and two huge storage tanks located in the boiler room of building F. The storage tanks are too large for its current hot water demand.

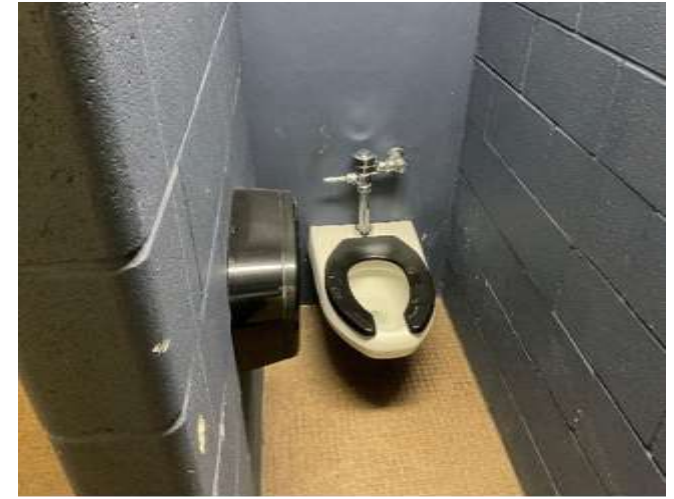
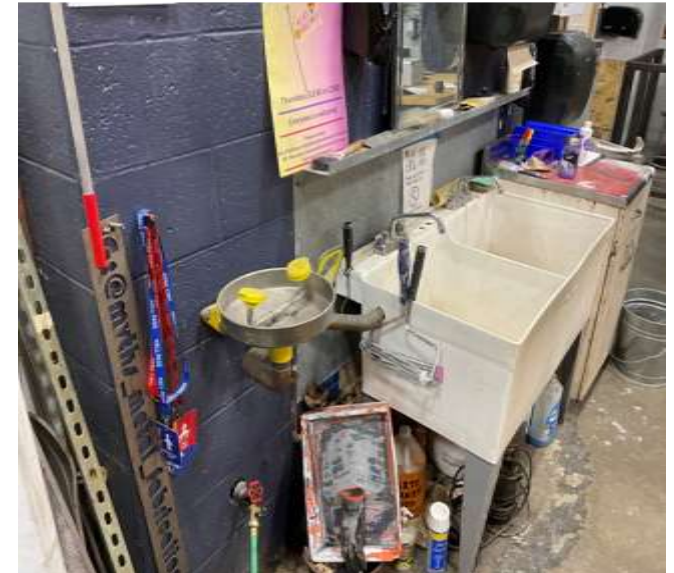
- During a substantial renovation and addition project, code would require that all the water closets, lavatories, etc. be modified to water conservation type fixture.
- Provide handicap accessible fixtures throughout the building in compliance with current code.
- Replace all mop receptors and janitor sinks with new fixtures and provide backflow protection for soap dispensers to comply with the code.
- Water of the appropriate temperature would need to be supplied to emergency eye wash fixtures in vocations and training areas whereby use of tepid water piping system or by tempering valves at fixtures.

- Secondary roof drains or scuppers are required to comply with current code.

- In the kitchen, install automatic shutdown with manual reset gas valve and interlocked with CO detectors to comply with the current code.

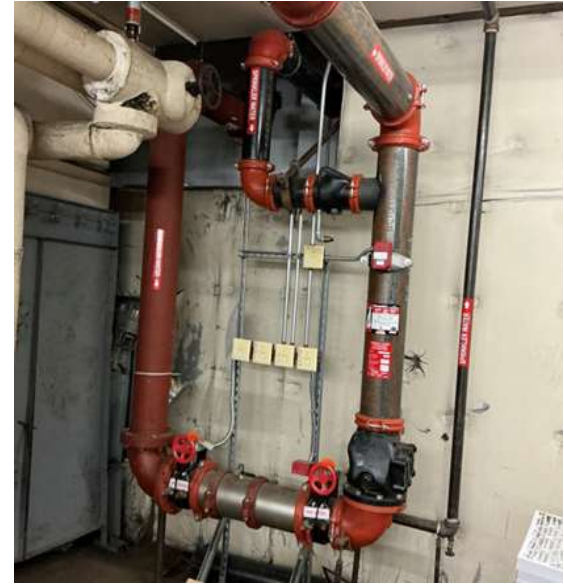
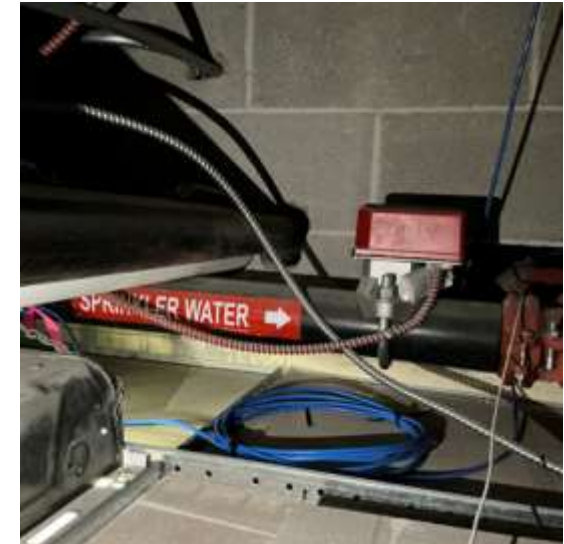
- Medford High school is partially sprinklered.
- Sprinkler system was added to the third floor of Area B as part of the Science lab renovations in 2015.
- Sprinkler system was extended to a small portion of the second floor in the Vocational Area as part of the Medford Public Access TV Renovations in 2016.
- All other Areas of the School building are not sprinklered.
- No standpipe

- 8" Fire water service with 8" Double check valve type backflow preventer and Wet riser check valve located in First floor Mechanical room.
- 4" Zone Control Valve Assembly located at third floor Area B Stair feeds the sprinkler system in the Science labs.
- Concealed sprinkler heads with white cover plates were observed at all areas with ceiling in the science labs.
- 4" main pipe was extended from the sprinkler main to feed sprinklers at the second floor.
- Recessed sprinkler heads with chrome escutcheon plates were observed all areas with ceiling .
- Upright sprinkler heads were observed in areas with no ceiling.
- A Siamese type free standing Fire department connection was provided at site.

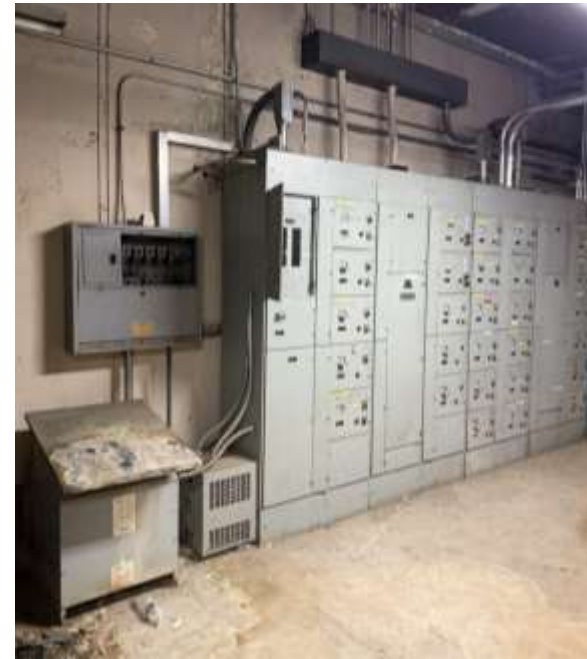
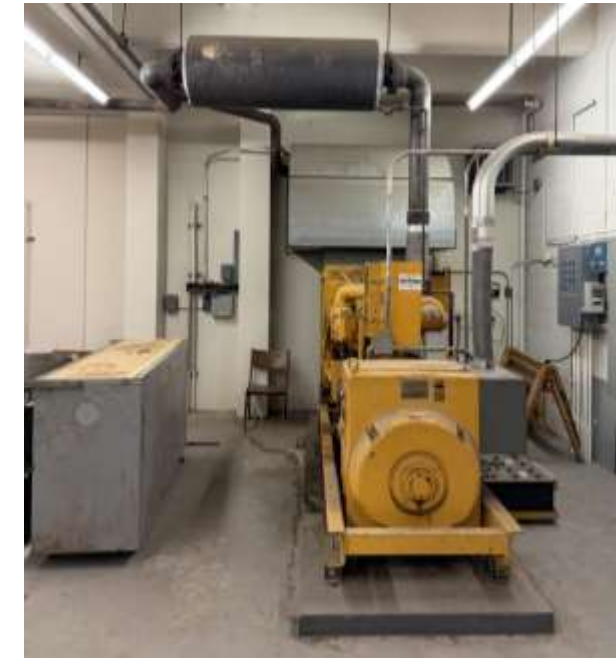
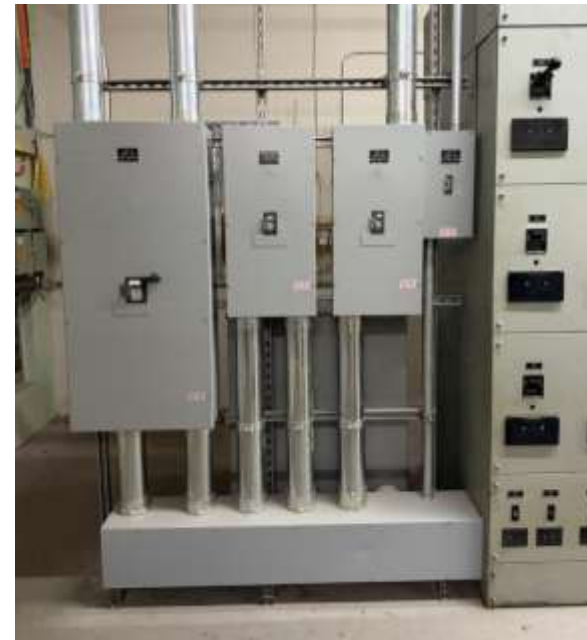
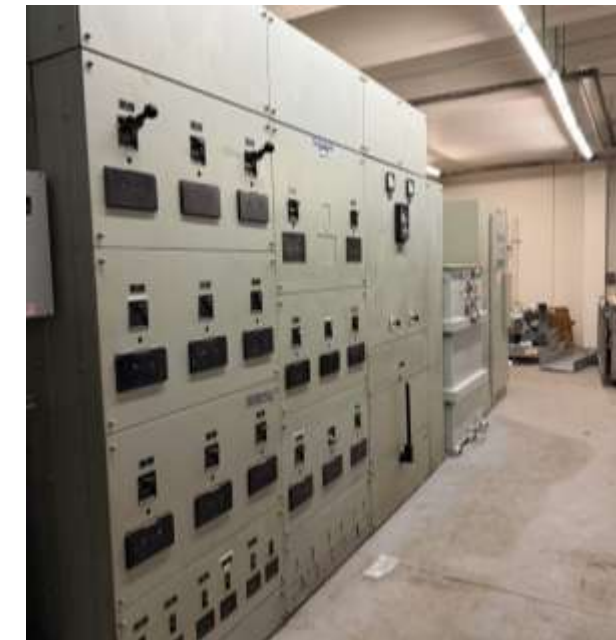
- Substation 1 - 2500A, 277/480 Volt via a 2000kVA Transformer
- Substation 2 - 1200A, 277/480 Volt via a 1000kVA Transformer
- Substation 3 - 800A, 277/480 Volt via a 500kVA Transformer
- Building service not equipped with Surge or GFI protection.
- (2) Emergency Generators (200kW & 175kW) - Non-functional.
- No observed Lightning protection
- Electrical systems are passed their useful life expectancy.

- Light fixtures were upgraded to high-efficient fluorescent bulb or LED technology.
- Lighting controls are basic line voltage controls with time clocks, daylight and occupancy sensors.
- Lighting control system does not meet current codes and standards for a lighting control system, which will be critical to meeting energy-use goals.
- Key features missing from the system include secondary daylight zones, automatic receptacle control, and automatic lighting control throughout.
- Emergency egress lighting and exit signs throughout the school are in fair working order. Some areas could benefit from additional signage.

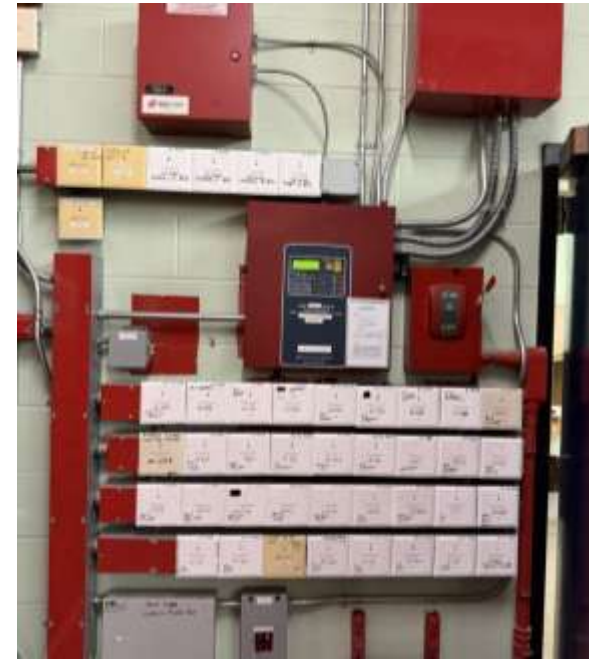
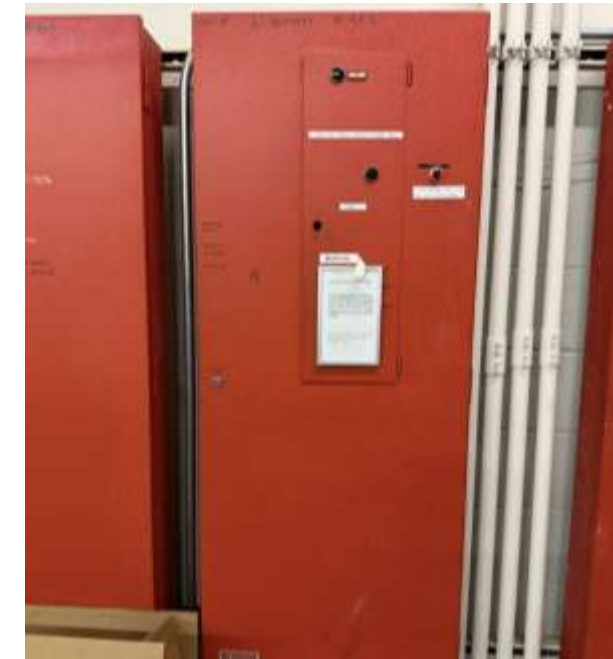
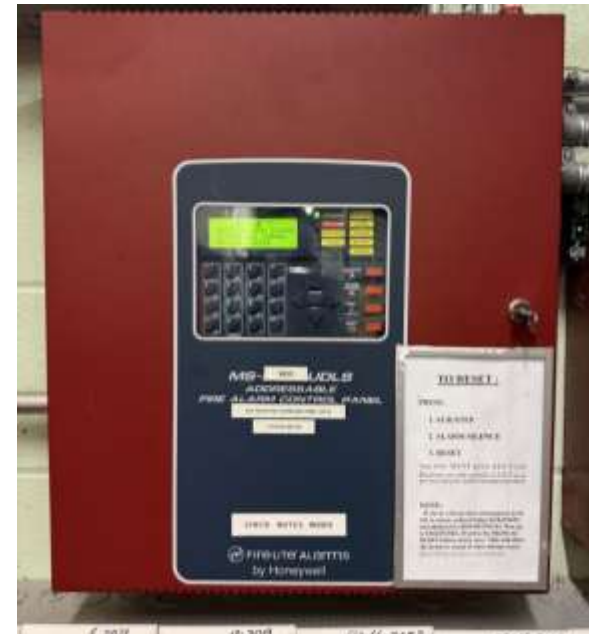
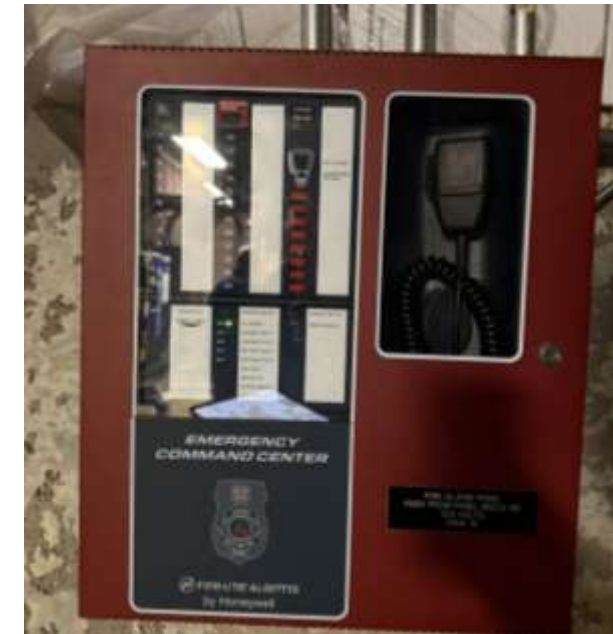
- The existing fire alarm system is Edwards for majority of the building and a FireLite by Honeywell for the 2014 renovation portion of the building. The Edwards system is a convention zoned system while the FireLite system is an addressable fire alarm system.
- No voice evacuation system, does not currently meet code.
- Fire Alarm coverage is sparse throughout most of the building except in the recent 2015 renovation.
- Lack of smoke detectors and sprinkler system does not currently meet code., exception being the 2015 Renovation.
- No BDA but equipped with Emergency Communications located throughout the building.
