# Medford High School

Medford Comprehensive High School  
Building Committee Meeting

12/22/2025

# Building Investigations

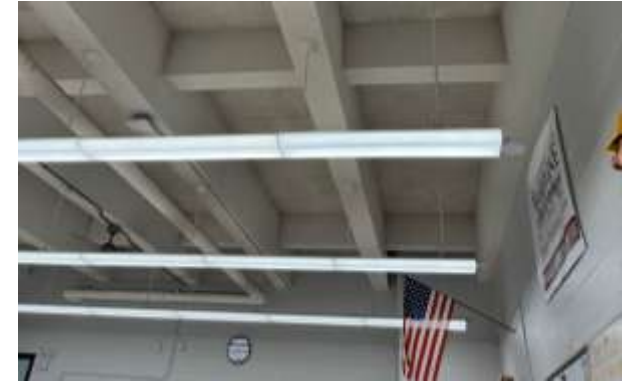
*Typical Concrete Framing in Classrooms*

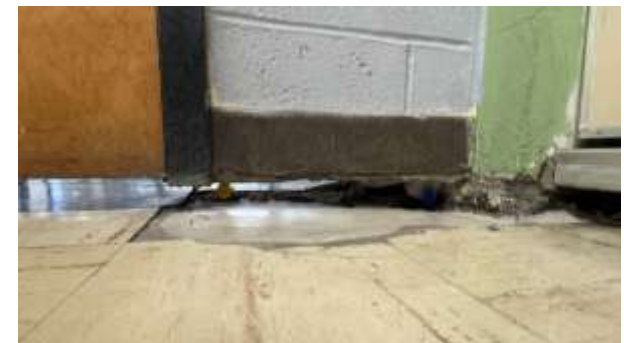
- Infill masonry walls not seismically braced at the top of the walls
- **Exposed rebar** in the underside of the concrete pool deck
- Settlement of the slab on grade in Wing C

*Slab Settlement in Wing C*

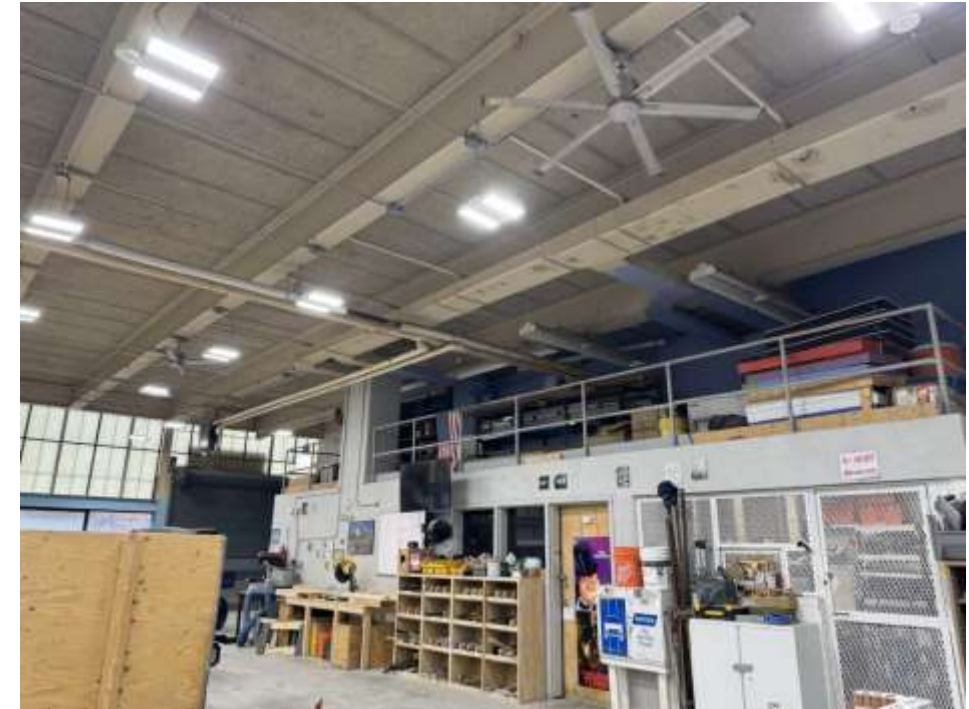
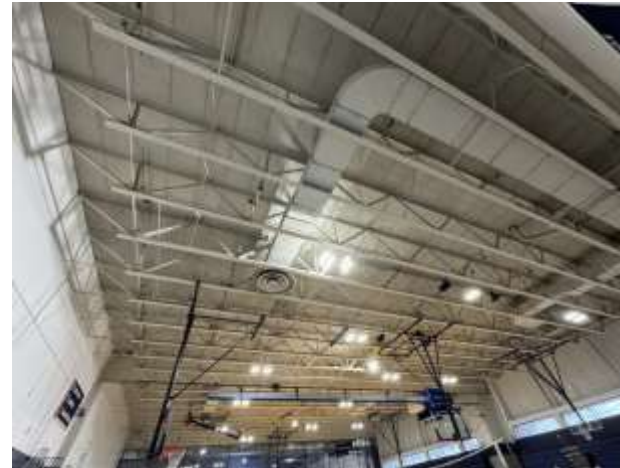
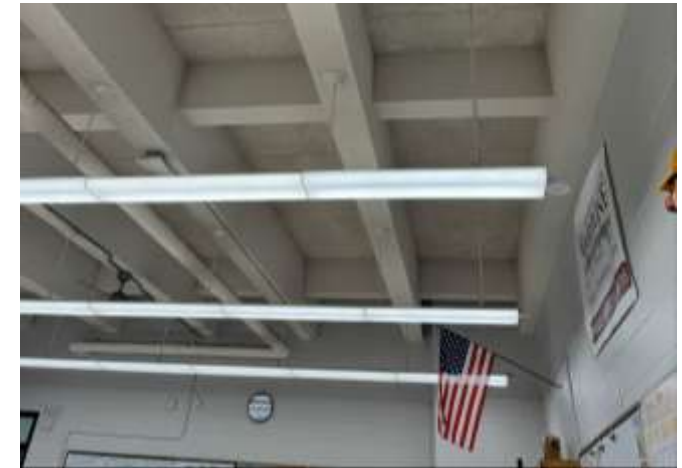
## Existing Conditions Survey: Structure

- Very Limited Existing Structural Drawings
- Foundations
  - Spread footings on bedrock with slab on grade at areas of shallow rock and framed structural slab at deeper elevations of rock
- Typical Classroom Wings
  - 6" thick one-way structural slab supported on concrete beams at 5'-0" on center and concrete columns
  - Flat concrete roofs with similar concrete framing
  - Unreinforced masonry infill walls not structural
- Gymnasium, Pool, Wings G and H
  - Steel joists or steel wide-flange beams and precast roof deck and steel columns
- ¾" Expansion joints between the Wings

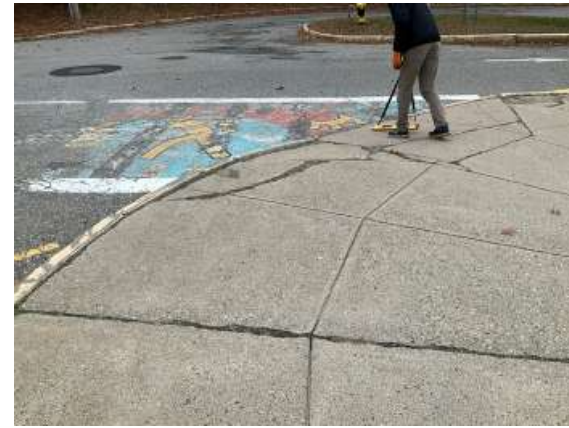
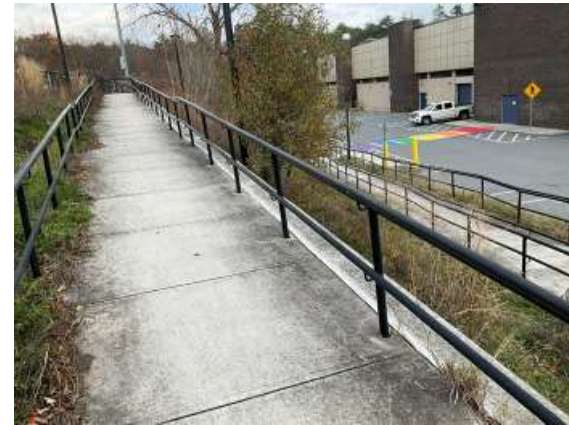
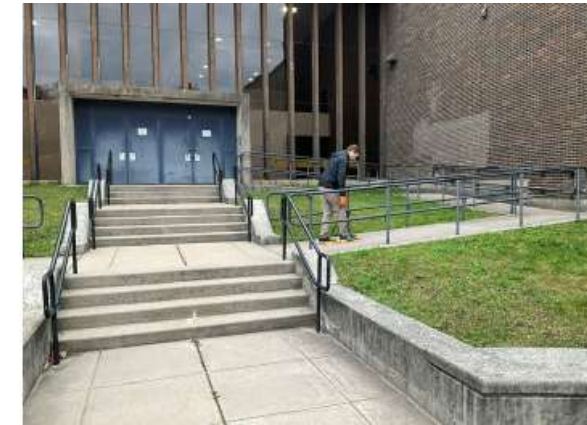
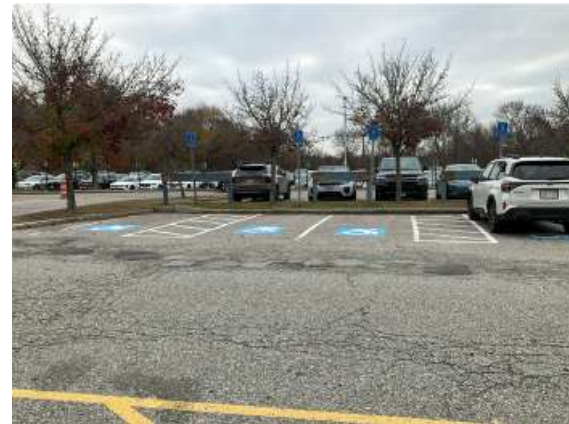
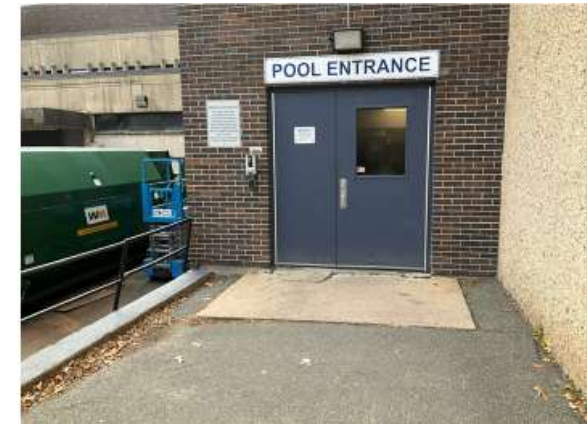
## Accessibility / Exterior Issues

- No accessible **passenger loading zones** provided
- Majority of **accessible parking spaces** have slope issues and/or non-compliant signage
- **Accessible routes** have various issues of non-compliance:
  - Excessive running and/or cross slopes along walkways, curb ramps, and ramps
  - Abrupt changes in level
  - No curb ramps provided at crosswalks
- Several **stairs** lack compliant handrails
- All **public entrances** are required to be accessible. Majority of entrances have barriers:
  - Some have steps and/or lead to stairs
  - Most door landings have excessive slopes
  - Many doors are too narrow and/or lack maneuvering clearance
